# Aircraft Carrier Flight and Hangar Deck Fire Protection: History and Current Status

**JANUARY 2005**

## **NAWCWD Technical Publication 8516**

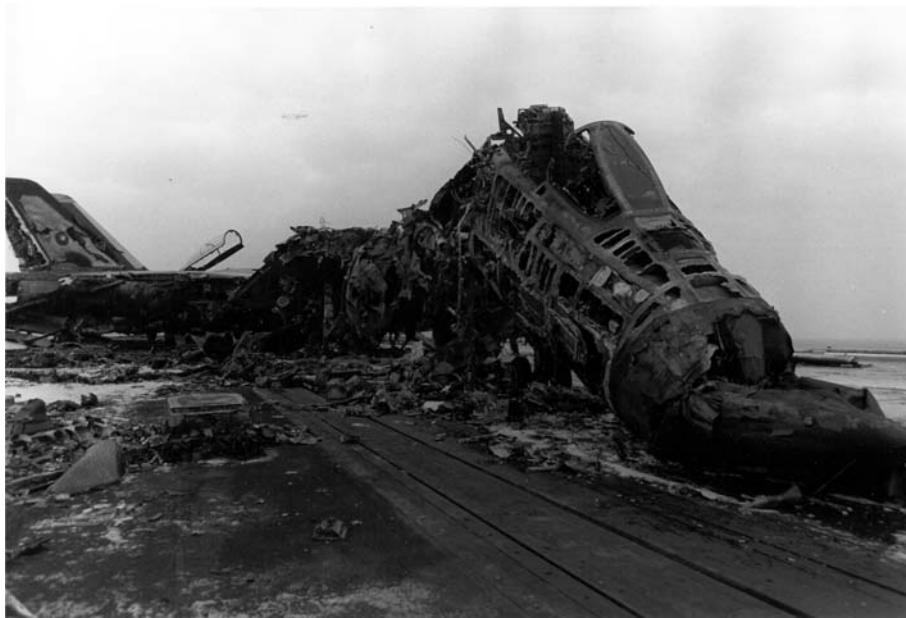
FIGURE 98. Totally Destroyed F-14.
